Summary of the Study

This three-year study is reported in a 79-page book that includes 98 figures.

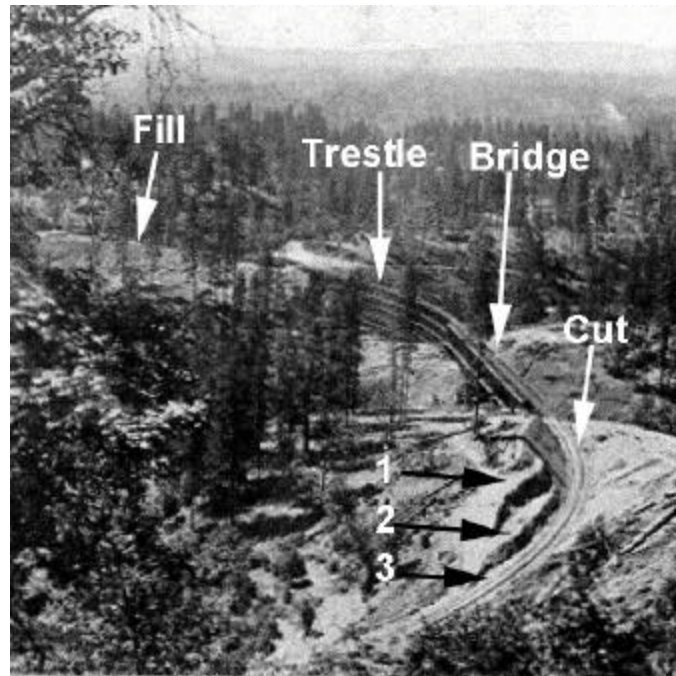
Figure 18 Choosing the best elevation for crossing Long Ravine Gap required compromising on the fill/trestle/bridge/cut as shown. The three cart roads that were used in 1865 are visible in the cut.

Construction Survey This section examines the reasons for locating the track bed at the 2500 feet elevation instead of locating it either higher or lower. The two gaps, Long Ravine and Secret Town, dictated the elevation at Cape Horn. Higher would have been easier while lower would have been far more difficult.

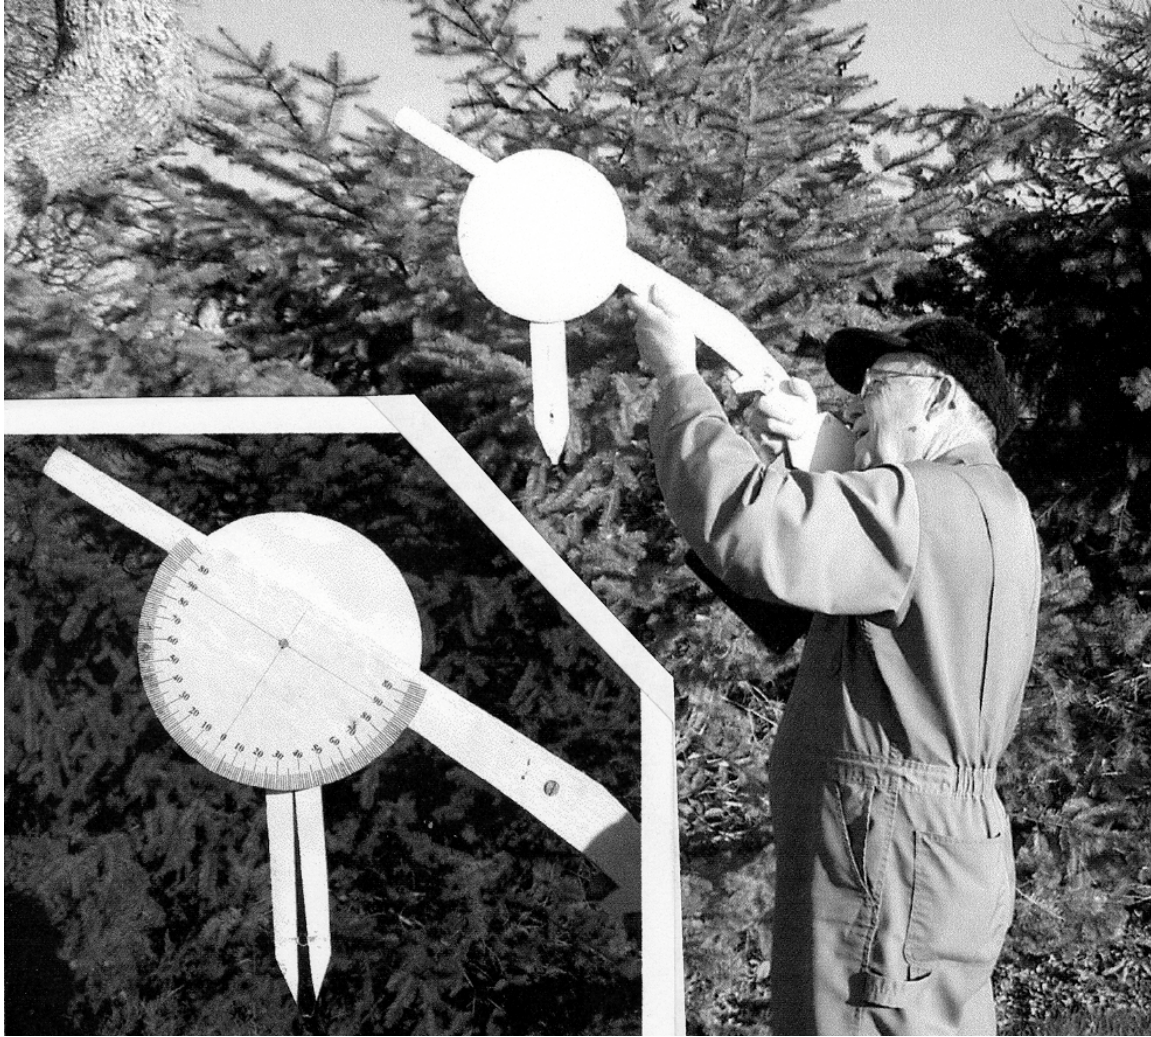
Figure 32 Slope gauge with weighted pointer reads 36 degrees. While using surveyor's equipment could make more precise measurements, this simple tool easily measured within 1 degree, which is adequate for this study.

Cape Horn Appearance in 2004 About 140 slope measurements were recorded along the 1000 foot Cape Horn in 2004 using the *slope gauge* shown in Figure 32. This convenient tool was used along the roadbed, also above and below the roadbed. Using these slope figures, cross sections of the existing cut were drawn at each 100-foot station. The reader can develop an excellent idea of the volume of rock that has been cut along this hillside by examining these cross sections. The vast majority of this excavation occurred in 1929, not in 1865.

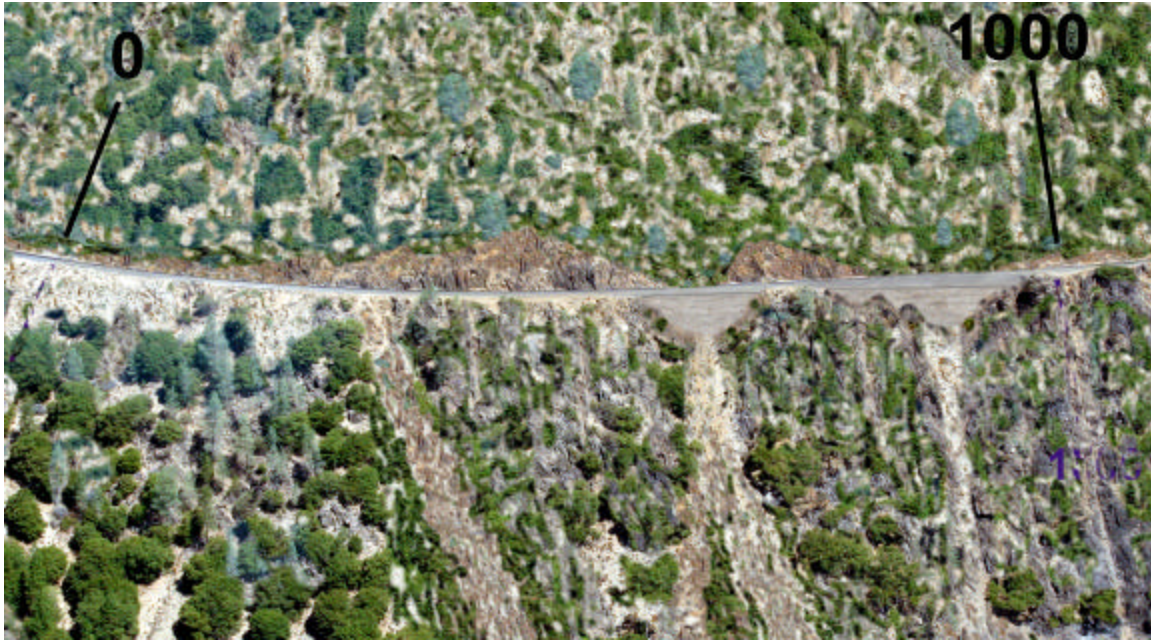
Figure 51 Cape Horn in 1866 after completion of construction.

The procedure used for developing the cross sections used drawings and photos from the 1860s and early 1870s. The results of this *back engineering* procedure are shown in Figure 51. Modifying the 2004 Figure 52 developed this figure. The purpose of Figure 51 is to show the small early cut compared to the present large cut. Brush and tree coverage is of course artificial but it is intended to indicate rather sparse cover as determined from many photos in the 1870s.

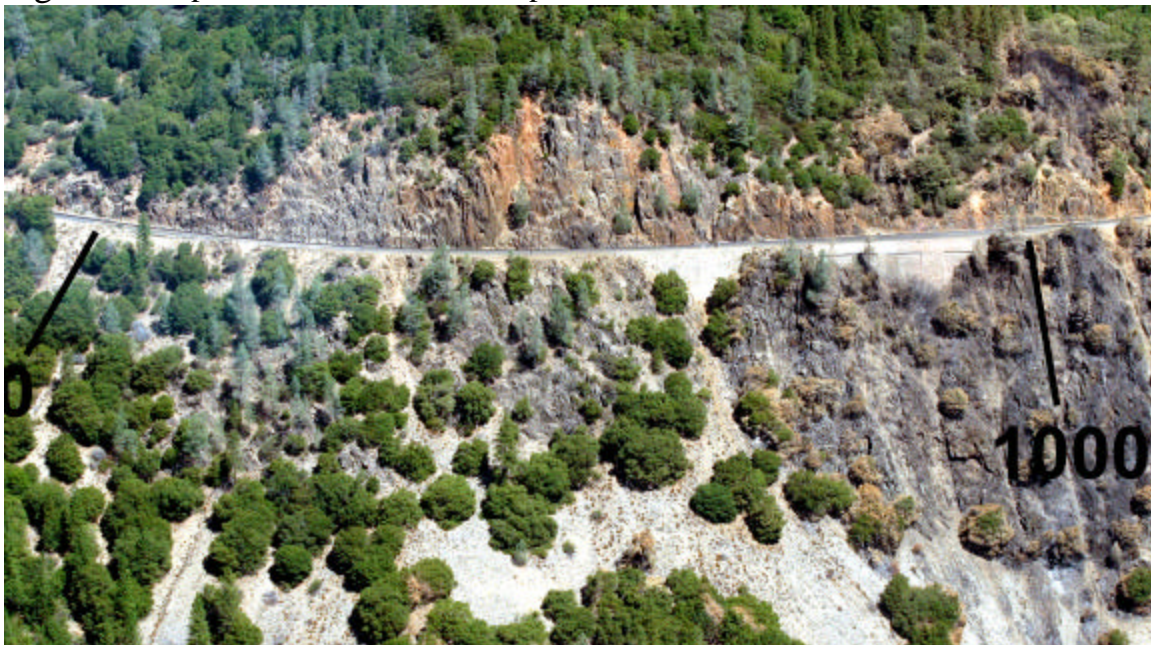
Figure 52 Cape Horn in 2004. Most of the additional cutting and some retaining wall improvements occurred in 1929. After 16 years of abandonment (1913-1929) this roadbed was improved allowing the eastbound, uphill traffic to be removed from Tunnels 33 and 34, and returned to this original 1866 location.
